SUCCESS STORY

PIPING INSPECTION USING MEC™

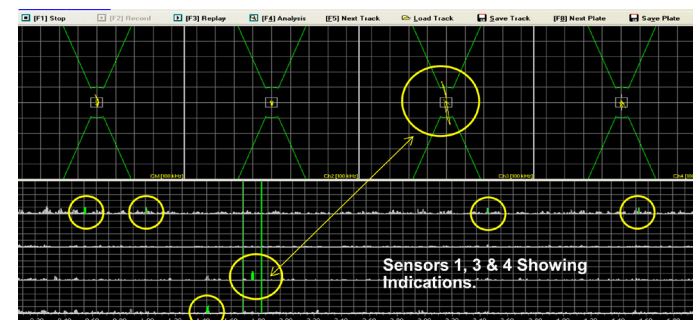
After intense surface scanning over multiple areas of the pipework, equating to a significant total meterage and nothing being detected, an area of pipeline was finally located with notable random indications being resolved, as seen along the scan tracks below.

ACTUAL PIPELINE 5M SCAN TRACK WITH INDICATIONS OBSERVED

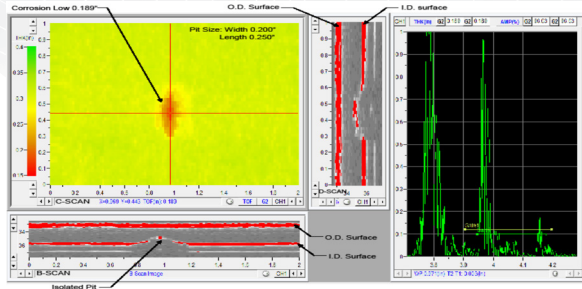
F3 HIGH RESOLUTION SCAN SHOWING CORROSION

For note these two particular internal isolated pits shown, were confirmed, and measured out at 5mm x 6mm and at a depth of 25% wall loss, and 3mm x 4.5mm at a depth of 20% wall loss, respectively.

Both these areas had been missed previously, by a routine manual Ultrasonic inspection.
