### ACFM Technique for Bolted Flange End of Life Wind Farm Towers

**Project:** Use of alternating current field measurement to assess the integrity of the wind turbine bolted flange welds and ensure no fatigue cracking were present.

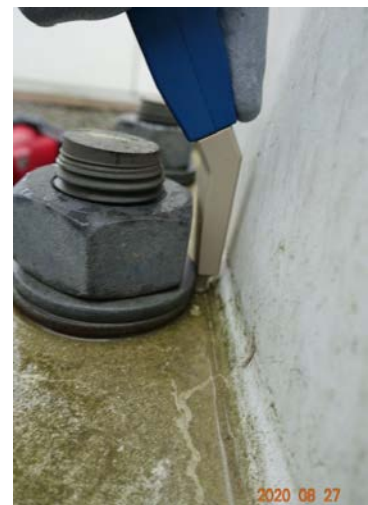
1. Remove the need to grit blast heavy paint coatings by using the Alternating Current Field Measurement (ACFM) technique which can detect fatigue cracks through coatings up to 4mm thick
2. The use of a long angled pencil probe which gives access to welds located behind bolts. This unique bespoke probe was utilised giving 100% access to bolted flange welds.

Photo 2. Long angled pencil probe gaining access to welds behind bolted flanges.
